## INDIANA DEPARTMENT OF ENVIRONMENTAL MANAGEMENT

**Poncies Water Sports**  
**FID# 12309, Incident# 200012502**  
Leaking Underground Storage Tank Program

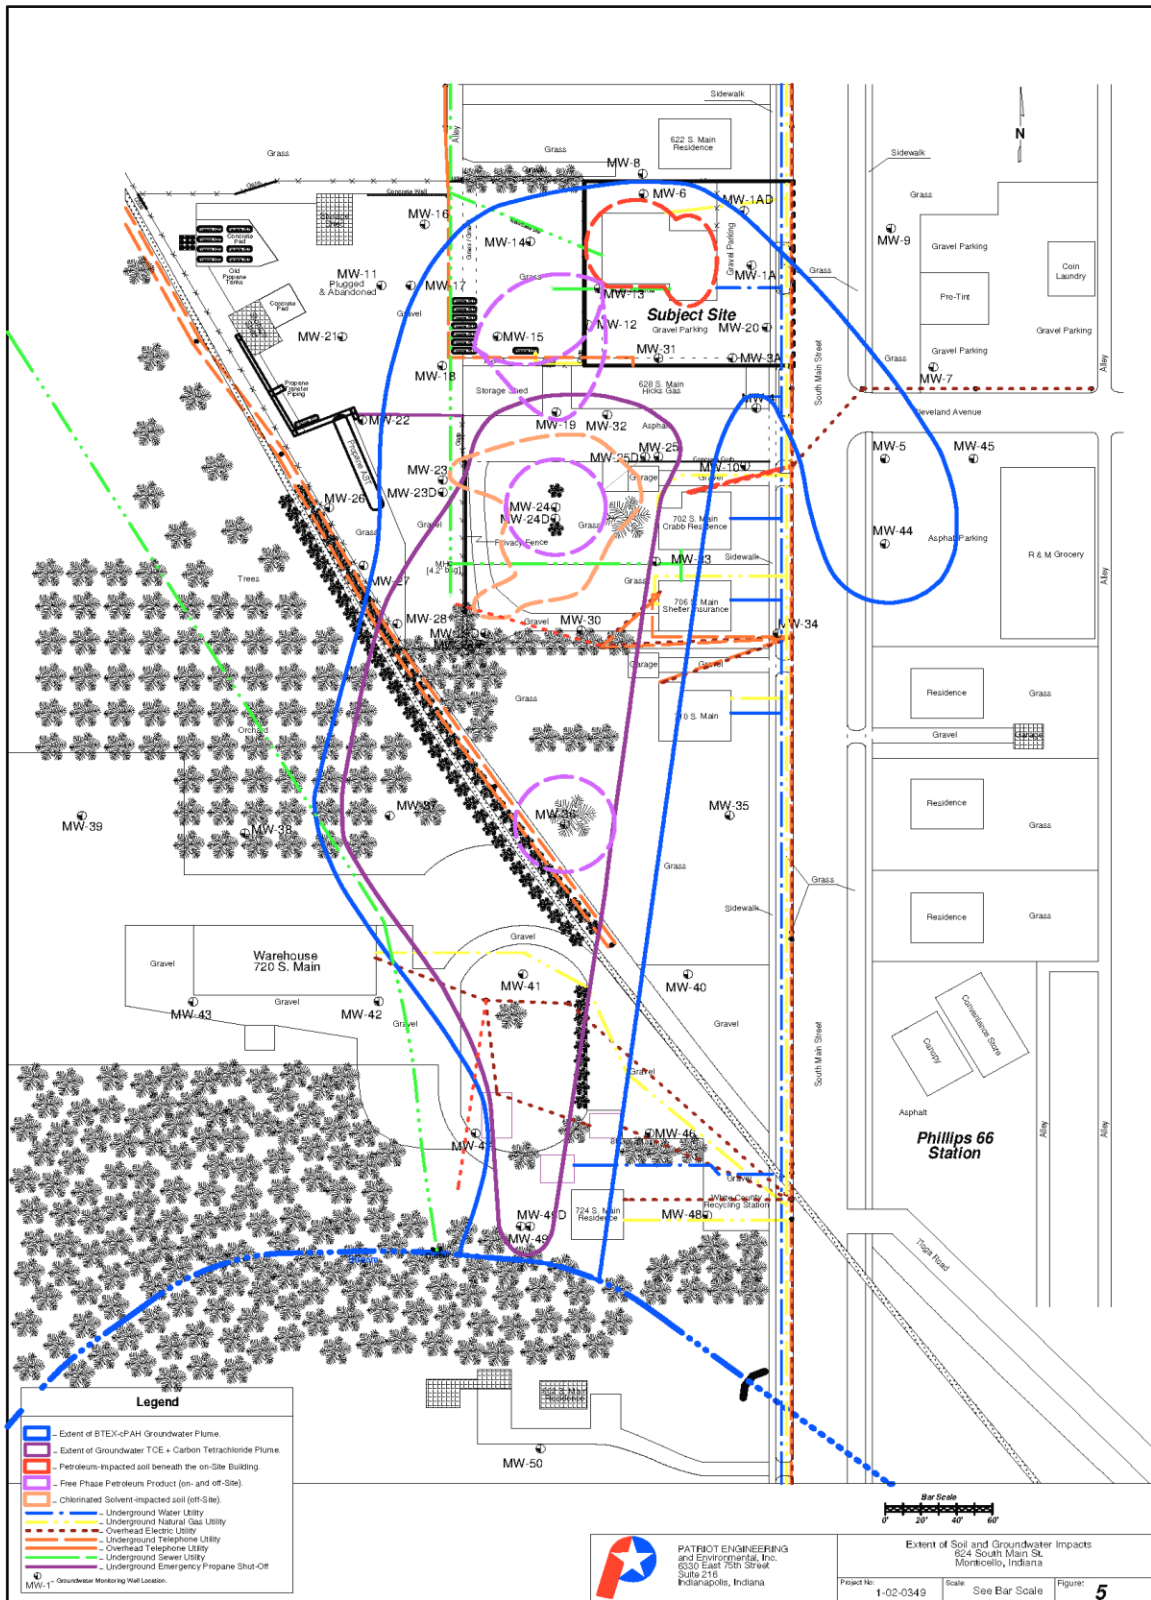
- Ground water monitoring shows that the dissolved petroleum plume is 560 feet long and 200 feet wide.
- Free product is present approximately 300 feet from the source.
- The chlorinated plume is 530 feet long and 160 feet wide.
- Petroleum contaminants have been detected in the ground water and in a stream near the terminus of the plume.
- Ground water impacts are present on the properties of eight different property owners.
- The plume surface area is over 3.5 acres.
- Testing found water and vapor impacts in a drainage tile over 400 feet from the source.
- Air samples collected in several buildings have been negative for vapor intrusion.
- It appears that the petroleum plume limits the extent of the chlorinated plume.

- A map showing the extent of soil and ground impacts is provided on page 3 of this Site Summary.
